D-172 New Market House East New Market private

c. 1850-1870

Maryland Historical Trust State Historic Sites Inventory Form

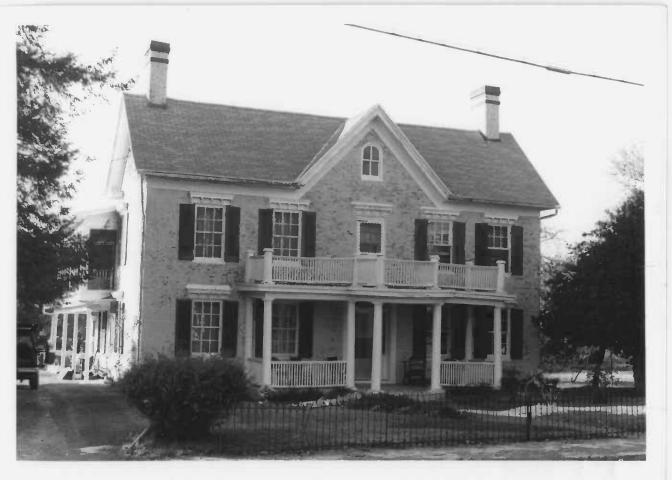
EAST ELEVATION
12/87 Paul Touart photographe

The east (main) facade is a slightly asymmetrical five-bay elevation with a center entrance and flanking six-over-six sash windows. The center six-panel door is framed by four-light sidelights and a five-light transom. The six-over-six sash windows to each side are distinguished by bracketed hoods and louvered shutters. The three center bays are sheltered by a Tuscan columned porch with a semi-circular center bay. Stretching along the porch roof is a balustrade consisting of square posts, square balusters and a molded handrail. The second floor is marked by a center entrance that allows access to the porch and flanking six-over-six sash windows. Bracketed hoods distinguish each of the five openings and louvered shutters flank the windows. A cross gable is centered on the roof and is lighted by a round arched two-over-two sash window.

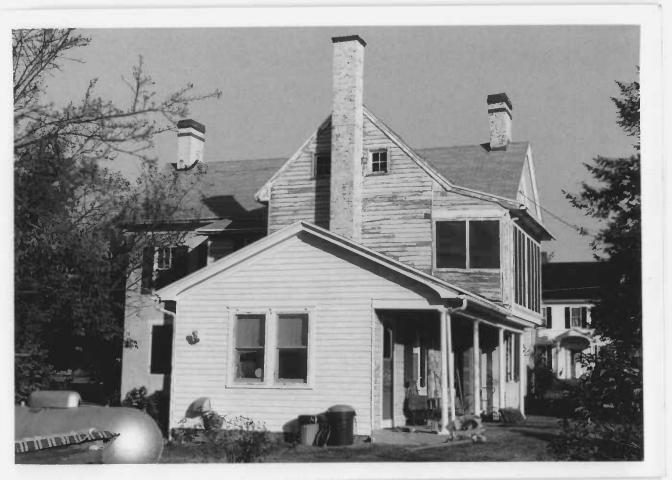
WEST ELEVATION

The west side of the main block is partially covered by the two-story frame dining room and kitchen wing. The south side of the wing is mostly covered by a two-story shed roof porch that is open on the first floor and screened in on the second floor. A turn of the century door provides access on the first floor to both the dining room. Attached to the west wall of the wing is a single story frame kitchen that is lighted by single-pane sash windows. An exterior brick stack rises through the roof of the single story kitchen against the gable end of the two-story wing. Small two-over-two sash windows flank the stack.
